Manhole Inspection Summary

Manhole # S19QQ_010MH

Insp Date: **7/10/07 9:04 AM**

Location Address: **1714 GWYNNS FALLS-WESTBURY** Cross Street: **REISTERSTOWN RD**

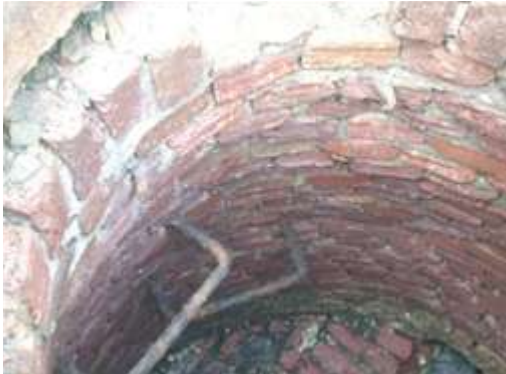
Defect 5

Condition: ☐ Sound ☐ Cracked ☐ Root Intrusion ☒ **Deteriorated** ☐ Leaks ☐ Debris

DEBRIS IN CHANNEL AND BENCH

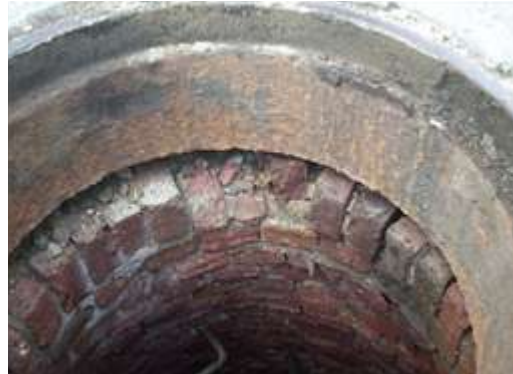
Defect 2

Condition: ☐ Sound ☒ **Cracked** ☐ Root Intrusion ☐ Loose Brick ☐ Deteriorated

CRACKED BARREL

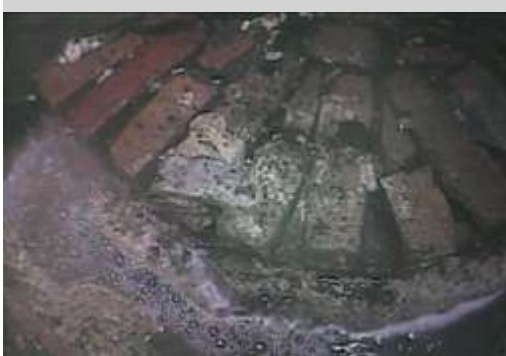
Defect 4

Condition: ☐ Sound ☐ Cracked ☐ Root Intrusion ☐ Loose Brick ☒ **Deteriorated**

DETERIORATED CHIMNEY

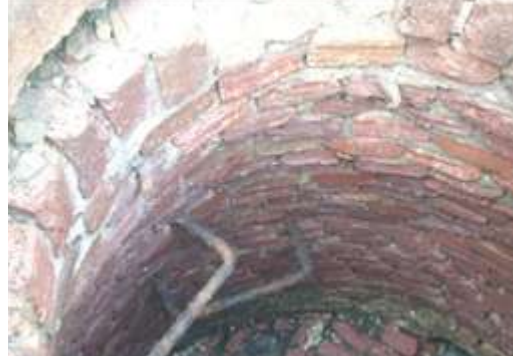
Defect 3

DETERIORATION OF BENCH

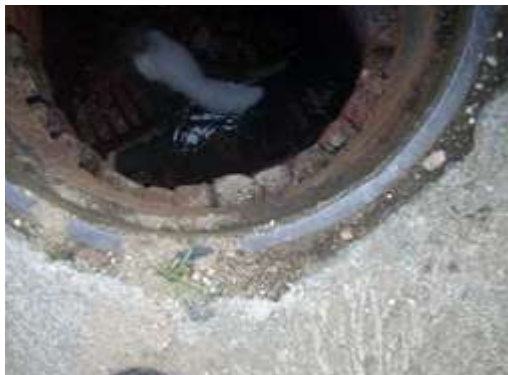
Defect 1

Steps Count: **2** Missing: **1** ☒ **Corroded**

CORRODED AND MISSING STEPS

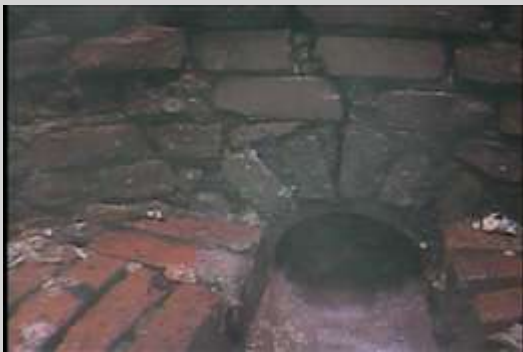
12 O'Clock Outflow

Frame Offset: **3** (in.) Condition: ☒ Sound ☐ Cracked ☐ Leaks

FRAME OFFSET
